TURBINE BRUSH SEALS

Adaptive exterior auxiliary turbine seals

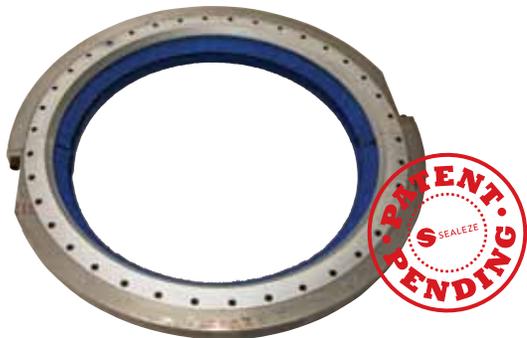
The exterior turbine brush seal is an angled, 2-layer brush system with an imbedded malleable membrane that improves sealing.

Brush seals have a long history of providing excellent sealing combined with high reliability. Thousands of filaments, as an aggregate, nestle tightly together creating an extremely dense seal. The inherent high elasticity dissipates stress under deformation, reducing drag, allowing a contact seal without generating any heat in the turbine shaft. Even multi-tier labyrinth seals inside turbines are now being replaced by single-layer brush seals because of their improved sealing capabilities (50-80% better), longer service life and greater reliability.

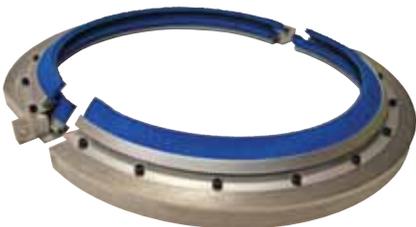
The seal ring is constructed in two parts for fast and easy installation. Simply attach to the turbine housing with 4-6 bolts and some RTV.

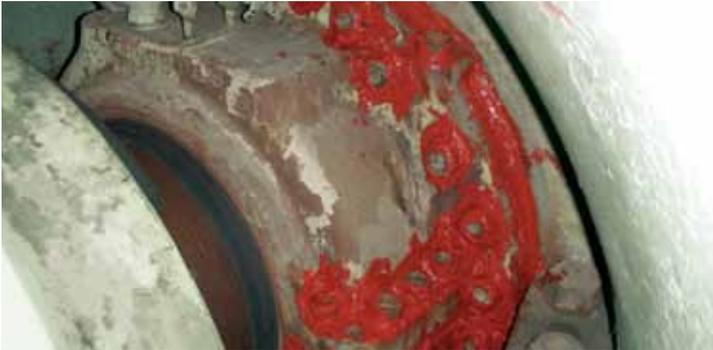
LP Turbine No. 1 South Gland Seal Housing before installation of seals.

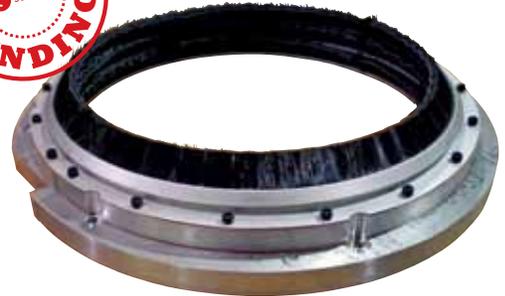
Auxiliary Brush Seal Installed:

LP No. 1 North Gland Seal Housing
The 2-Layer Turbine Seal is 2.375" in depth.

Location	Before	After	Reduction
LP#1 South	60,000+	3,600*	94.0%
LP#1 North	30,000	5,200**	82.7%
LP#2 South	48,000	1,800**	96.3%
LP#2 North	60,000+	6,200*	89.7%

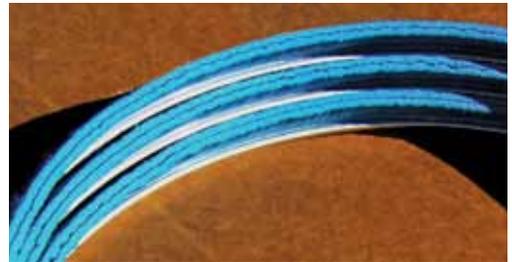
3-layer Auxiliary Turbine Brush Seal with heat stabilized nylon filament. The 3-layer turbine brush seal is 3.25" in depth.

For enhanced sealing and extended functional service life, Sealeze has developed a 3-layer seal system with advanced filament and membrane materials.
